Aquarius Spectrum Ltd.

Water Leak Detection in a challenging PVC piping: A successful Pilot in Key West Florida

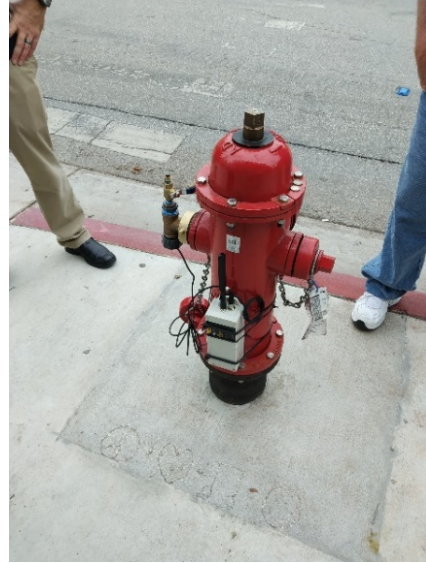
Figure 2 – Typical sensor installation

Aquarius installed 7 hydrophone sensors to cover half of the selected pipeline (see figure 1 below). The sensors were installed 450 to 700 ft. apart on aboveground hydrants (see figure 2) and empty meter boxes.

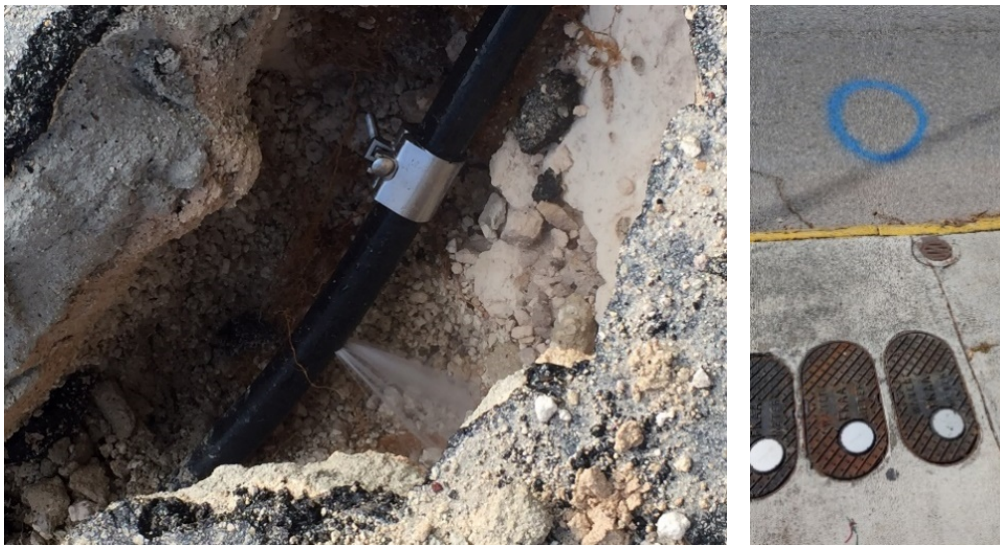
Figure 4 – The leak location was found and fixed

The highlighted blue line is a branch, attached from the main to the consumer water meter. Two leaks were found and verified with a ground microphone (see figure 4 below). The digging had found two leaks over the same branch and repaired them using a clamp.
